GABLE WALL ISSUES

By Mark Doyle

A large Gable Wall with 2 hanging chimneys

PRESTON, LANCASHIRE

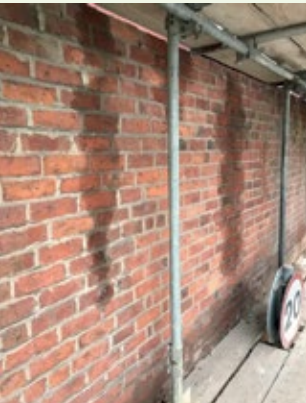
Photo 1:
Gable wall cavity holding water

Infilled cavities: Material does fall into the cavity of walls during construction and can get washed in if there are cracks and leaks. These areas of infill can show up externally, particularly after prolonged wet periods and storms, as large damp shapes visible in the mortar layer on the wall. There is also considerable momentum building that the addition of Thermabeed insulation to some wall cavities not suited for insulation (ie thin cavities less than 50mm wide). Although thought to be free draining, water can also be retained in wall cavities.

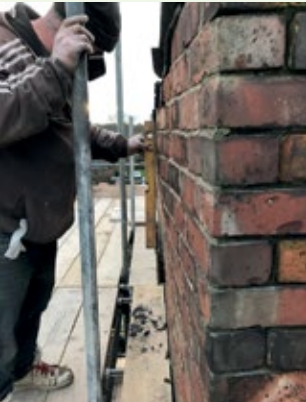
Chimney stack leaning: Chimney stacks were often built up the inside of a gable wall, usually feeding chimneys into two ground floor rooms and two first-floor rooms (although they may contain more flues to basement or second floors, etc). In a typical two-bedroom terraced house these chimneys could have a stack on the roof, ranging from a small 60cm structure up to a two-metre high, two-tonne brick structure. If for any reason the structural support fails below the exposed stack, they will start to lean over and in time, these will collapse.

Photo 2:
Chimney stack leaning

This building is a 4 story Edwardian terrace of 4 buildings, with a large gable wall containing 2 large chimney breasts and several windows in poor condition. This wall was sagging outward by 100mm and the 2 large chimney stacks on the roof were leaning dangerously over the main roof (see photo 2 & 5 above). Other observations included, sloping floors, internal floor to wall separation (see photo 4), cracking of perpendicular walls (see photo 3), movement of windowsills, horizontal cracking in mortar beds and deterioration of mortar.

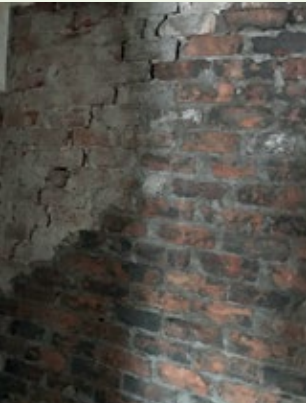
Photo 3:
Internal wall cracking

Internal wall cracking: Internal walls perpendicular to a gable wall are usually tied into it to support its structure. However, should these walls lose support on one side, they will crack (usually at roughly a 45 degree angle following the line of weakness through the wall's mortar beds). These cracks may be obvious, but equally they may only be visible as a shear-type pattern in wallpaper and plaster.

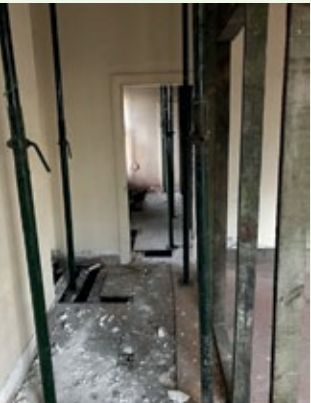
Floor to gable wall separation: When examining the floor adjacent to a gable wall, sometimes a clear gap or larger than expected space can be seen between the floorboards and wall. Signs of movement may be obvious on the floorboards showing where the skirting boards originally sat but have now been displaced.

It's also worth bearing in mind that the floor joists usually run parallel to a gable wall and are rarely tied into the structure. However, where chimneys are present, shorter lengths of floor joists usually run at a right angle to tie into the gable wall. In either case, large gaps may exist, which signal movement is taking place.

Photo 4: Floor to gable separation along the left side

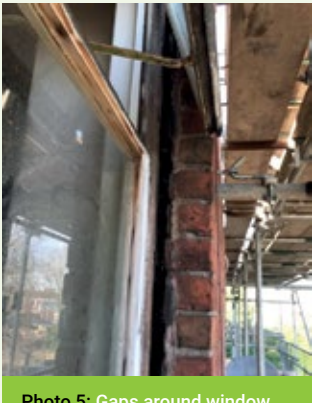
Lintel or sill movement, twist and separation: A lintel over a window or a sill below a window may lead to one side, twist, rotate and gaps may appear around its edge. Again, this shows some movement taking place. Often these lines of disturbance can be followed across a building from doorway to window to window and so on.

Sagging or bulging gable walls: A gable wall that bulges, sags, is concave, and/or convex in places is an indication of structural failure within the wall itself. It is almost impossible to do a simple repair and usually needs a re-build.

Photo 5: Gaps around window, sill and lintels in gable wall showing 100mm outward bulge.

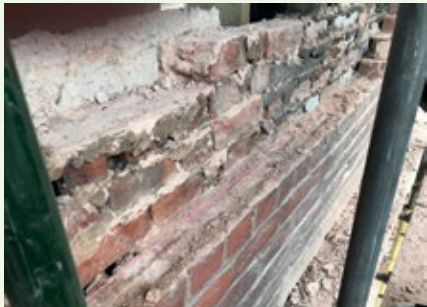
Photo 6: Solid 9" wall with crumbling mortar in poor condition

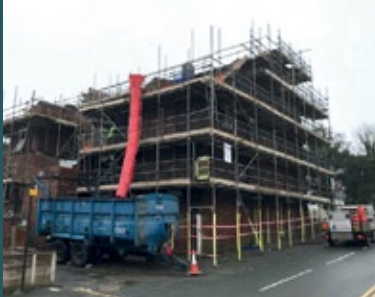
Photo 8: Scaffolding in place

Due to the size of the gable wall a 5/6 lift scaffolding platform was erected and the chimney stacks and both courses of brick wall were carefully removed brick by brick from the structure. The wall was rebuilt over a period of 4 months due to poor weather delays and additional structural issues. All the works in connection with the Gable wall cost £20,000.

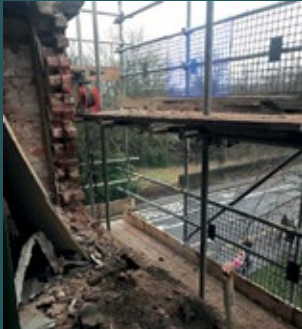
Photo 9: Visible chimney flues & solid 9 inch wall

The situation was compounded when it was realised that the chimney breasts had been removed at lower ground & ground floor levels to open a double fronted shop. These works had included the installation of a large steel box in the ground floor ceilings to support the building. But this had left the 2 chimneys and approximately 40 tonnes of brickwork hanging off a 100mm/4" steel

beam that had been run under the chimneys in the ceiling of the ground floor. Not surprisingly gravity was acting on the wall which was slowly moving downward (hence the bulge).

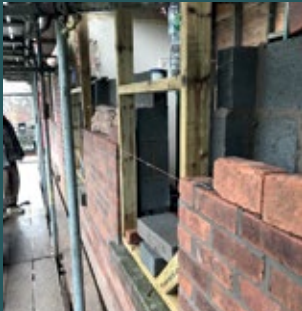
Photo 10: New cavity wall, internal dense block, insulation, wall ties & facing brick

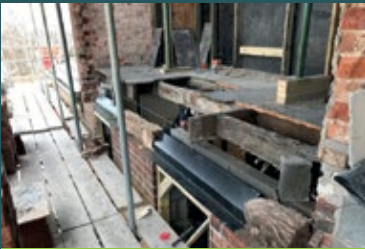
Photo 11:
New Catnic lintels over windows

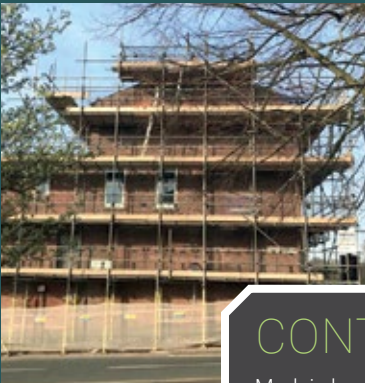
Photo 12:
New wall topped out & completed!
